✓
AFML-TR-72-30

INSTALLATION OF A SELF-SEALING MATERIALS
SYSTEM IN A C-130 INTEGRAL FUEL TANK WING

Northrop Corporation
Aircraft Division

September 1972

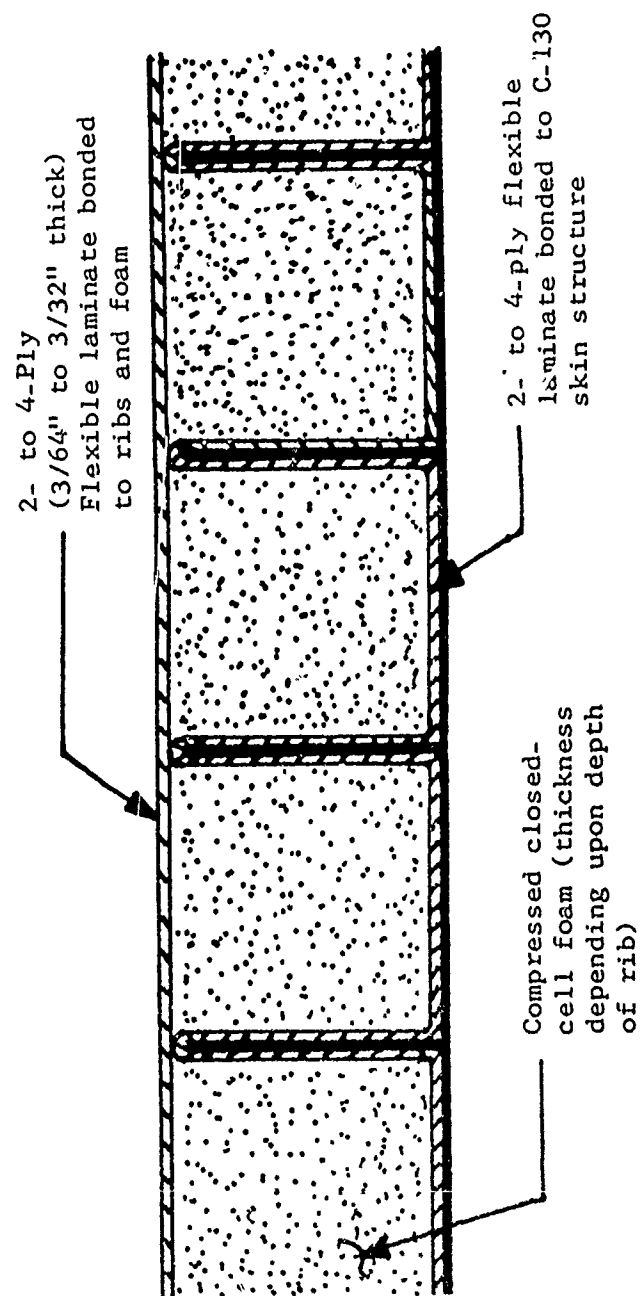
FIGURE 1. C-130 SELF-SEALING PANEL CONFIGURATION

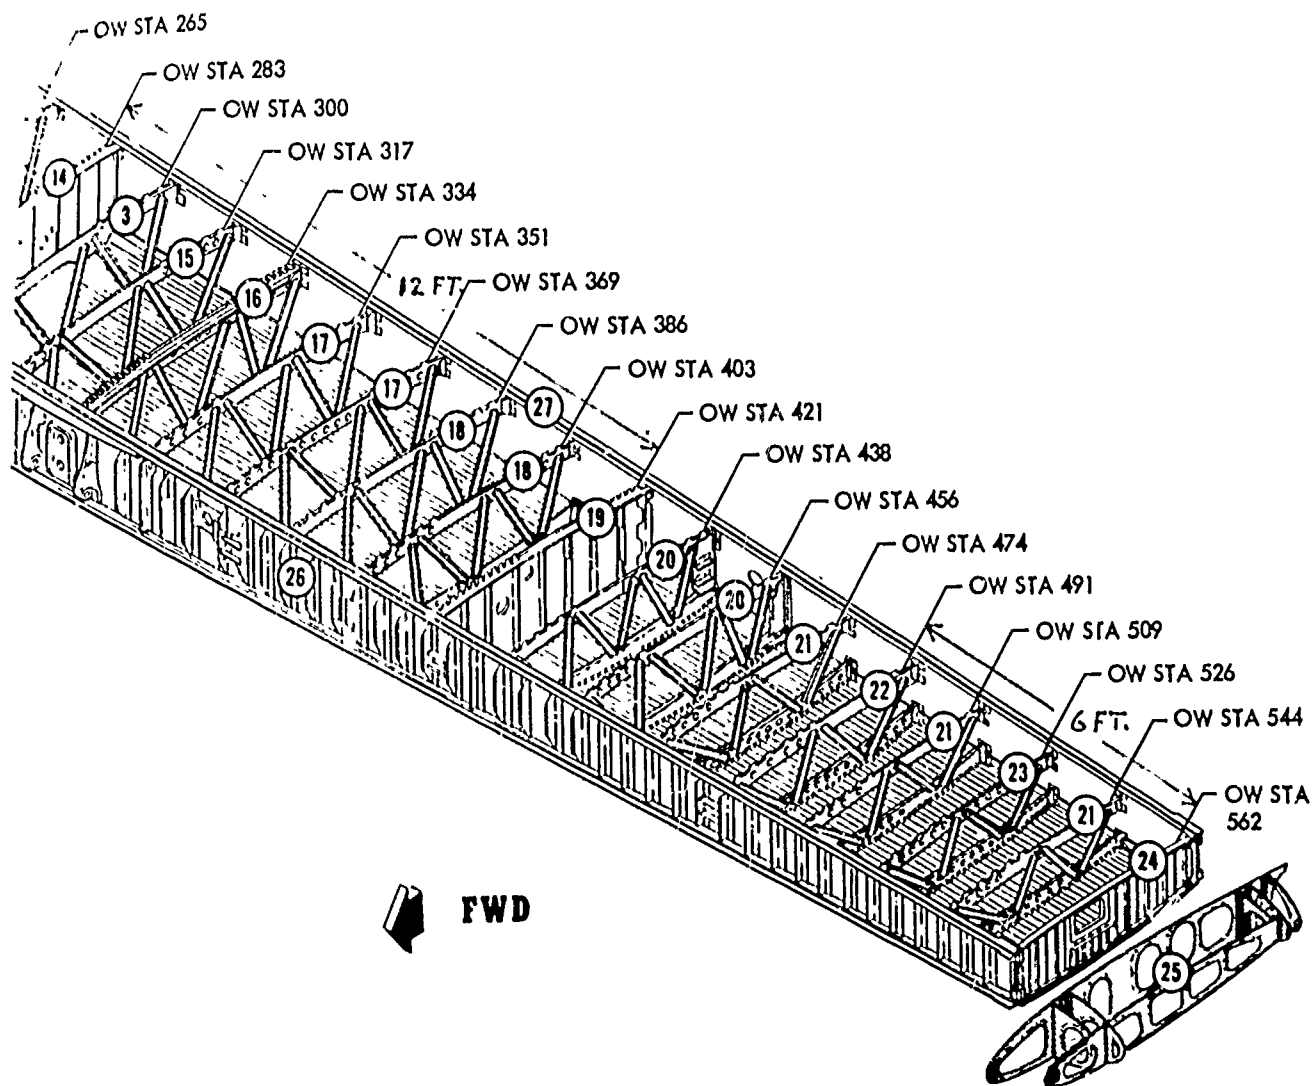
FIGURE 2. OUTER WING BOX BEAM STRUCTURE

The prepared corrugated laminates were cut to fit the symmetrical and asymmetrical sections of the tank bays. As is depicted in Figure 2, the bays in question were OWS 491 to 509, OWS 509 to 526 and OWS 526 to 544. The bay OWS 544 to 562 was left without any protection. The technique used to bond the laminates to the bottom of each of the three bays consisted of three major steps. Step one was to brush MEK diluted 898 sealant onto the MEK cleaned surface where the laminates were to be bonded. Step two was to install the MEK cleaned laminates to the bonding area and apply pressure against the laminates by means of a series of turn barrels inserted inside the tank between the top section of the tank and the laminates at the bottom section of the tank, as shown in Figures 25 and 26. The asymmetrical corrugated corner laminate and the symmetrical corrugated laminate were made to overlap at an area between two ribs. To apply a uniform pressure across the laminates and obtain a uniform bonding at all points of the laminates, special wooden blocks that fit snugly between each two ribs were used (Figure 27). To simplify the setting up of the turn barrels and to obtain a more uniformly distributed pressure across the laminate, large metal plates were placed on top of the wooden blocks as shown in Figure 28. Step three was to cure the 898 bonding material. This was performed by rolling the tank into a large oven and heating to 180°F for 1 1/2 hours. A 1/2 hour was allowed for cooling off the system to room temperature. After removal of the turn barrels, metal plates and wooden blocks, inspection showed an excellent and uniform bond of the laminates was obtained (Figure 29).

The fabrication of the four-ply corrugated laminates for the firing test tank bays, bottom sections OWS 283 through OWS 403 (see Figure 2), was performed in a manner similar to the fabrication of the corrugated laminates for the slosh and vibration test tank (see Section C above). The only exception was that the mold used for the slosh and vibration test tank had to be modified slightly. The ribs had to be increased in height from 5/8-inch

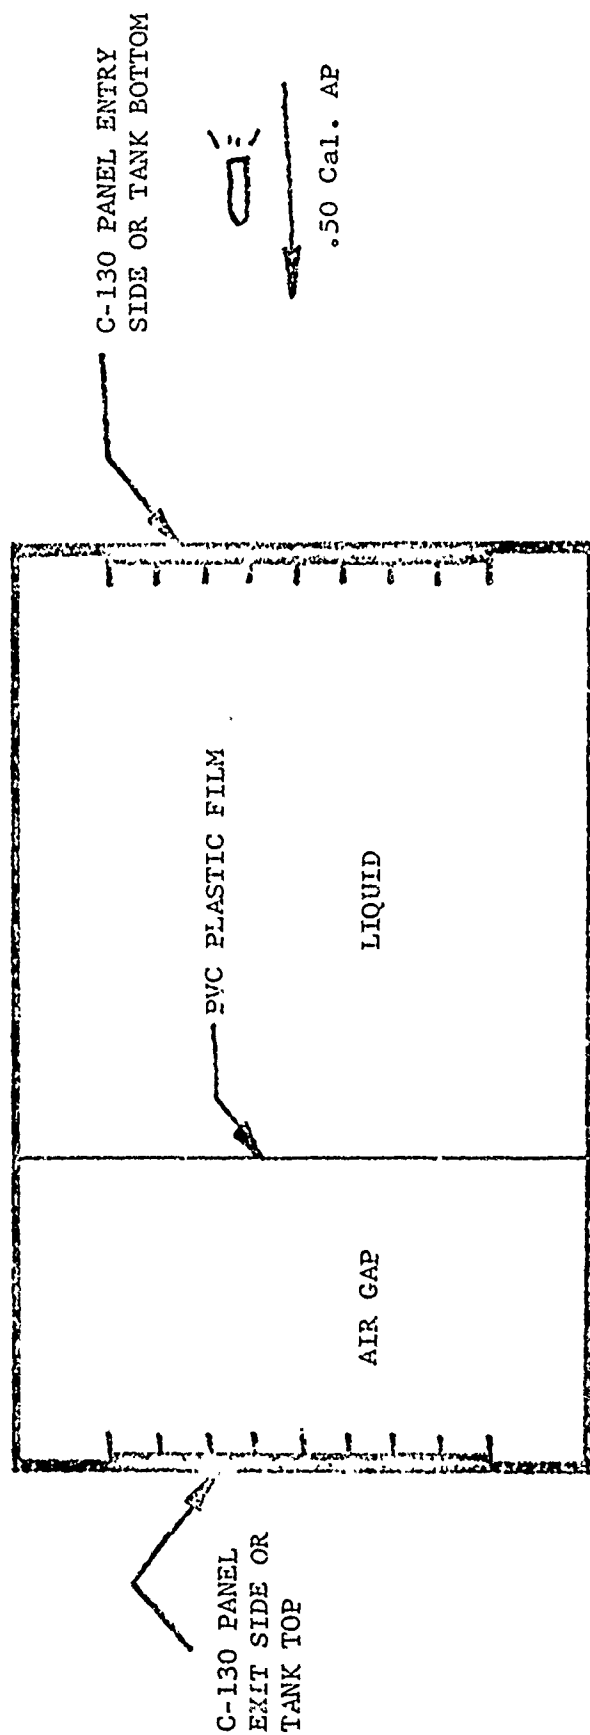
FIGURE 3. TEST SETUP SIMULATING VERTICAL SHOTS

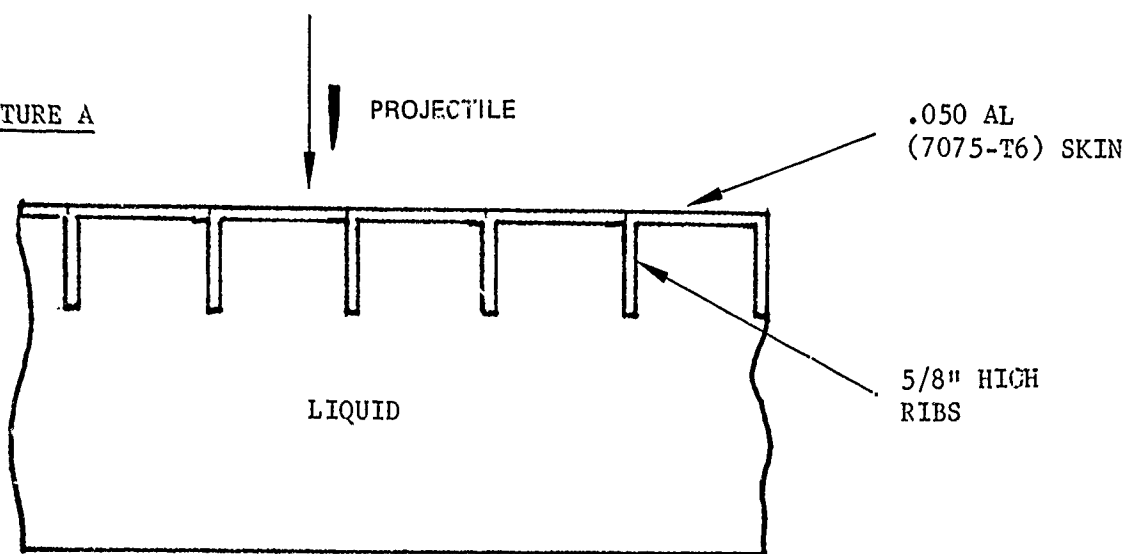
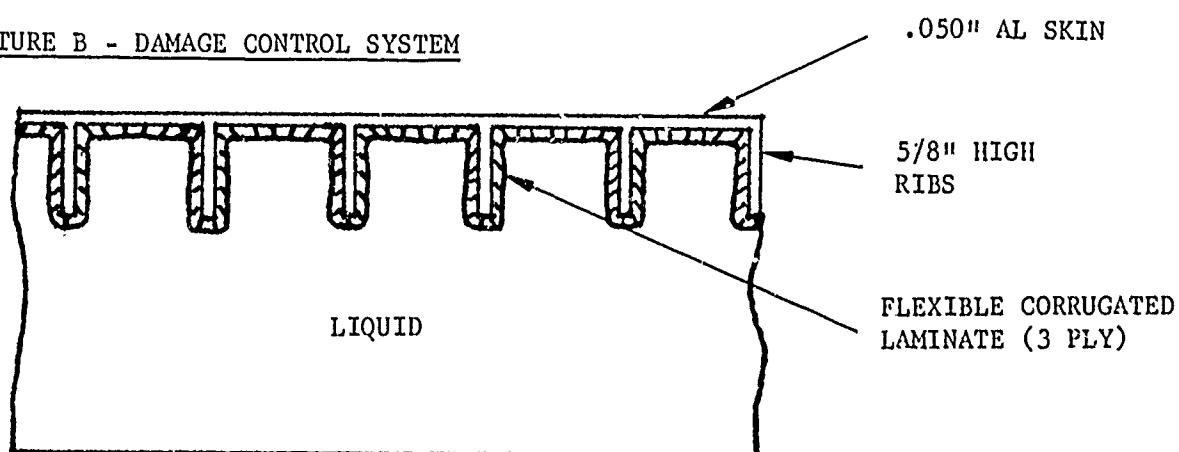
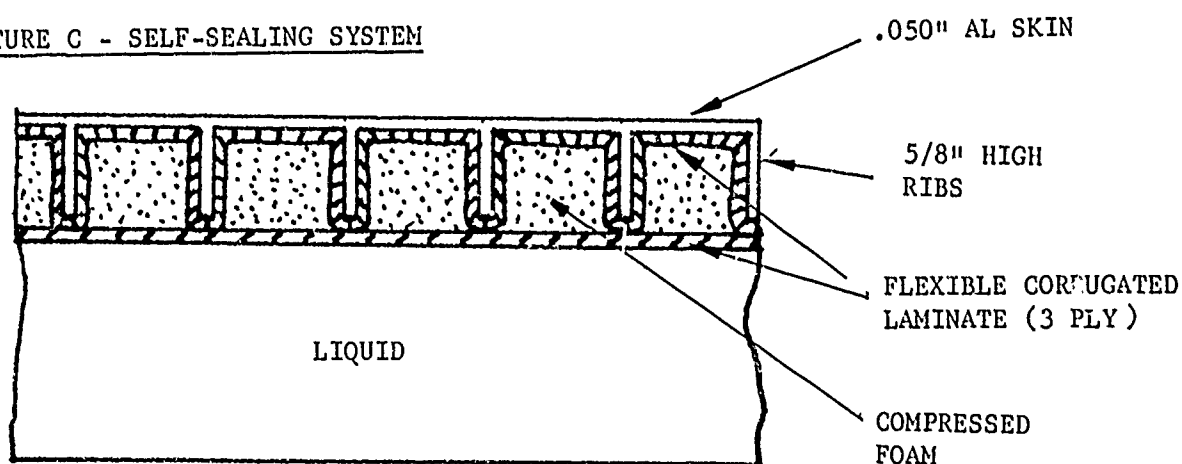
STRUCTURE A

STRUCTURE B - DAMAGE CONTROL SYSTEM

STRUCTURE C - SELF-SEALING SYSTEM

FIGURE 4. C-130 INTEGRAL FUEL TANK WING STRUCTURES

In this series of tests, panels having a configuration of Structure A (Figure 4) were mounted at the entry and exit side of the tank setup. In test, when the .50 caliber AP projectile impacted between two ribs at the tank entry side, a clean hole with no rupturing was obtained in the entry panel skin. At the tank exit side, the projectile penetrated the panel in a tumbled condition hitting a rib and rupturing the exit C-130 panel heavily. However, when the projectile hit a rib of the panel at the tank entry side, the entry panel skin structure ruptured heavily as shown in Figure 5. The panel at the tank exit side was hit by the tumbled projectile. Rupture was minor, as is shown in Figure 5.

Panels having the configuration of Structure B (Figure 4) were mounted at the entry and exit side of the tank setup. The same impact conditions as for Structure A configuration were used; that is, a penetration between two ribs and a hit of a rib. When the projectile (.50 caliber AP) penetrated between two ribs at a 90-degree angle of incidence, the entry panel skin showed only a small hole. This was almost sealed by the corrugated laminate as shown in

In this series of tests, panels having the configuration of Structure C (Figure 4) were tested at the tank entry side against .50 caliber AP projectiles impacting in either a 90-degree or in a 45-degree angle of incidence. The results obtained in the 90-degree angle of incidence shots are illustrated in Figure 11. Of the fourteen shots which penetrated the panel, ten were between ribs, three brushed the ribs, and one hit one of the ribs. After each impact, immediate sealing was obtained by the combination of the ballistic nylon laminates and the precompressed foam. No rupturing or cracking of the skin was experienced. The liquid loss was insignificant, which showed that the mechanical self-sealing mechanism had worked efficiently. The results obtained in the 45-degree angle of incidence shots are illustrated in Figures 12 and 13. Two 45-degree angle shots were performed in this panel. In a first shot the projectile penetrated between two ribs and hit a rib on its way in. The puncture sealed immediately and no leak was observed. In the second 45-degree angle shot, the projectile hit a rib at entrance. Again efficient sealing was obtained.

Based on the successes obtained above, it was decided to use the self-sealing system illustrated in Figure 4 for installation in the C-130 slosh and vibration test tank and firing test tank.

As illustrated in Figure 4, the precompressed foam, which is located between the ribs of the C-130 skin structure, is the self-sealing part of the self-sealing materials system. To put the foam in a compressed state, the foam strips were cut oversize and forced between the ribs. Besides providing seals, the foam also helps by absorbing the hydraulic ram pressure to reduce damage to the C-130 skin structure. The type foam used was the Buna-N (Nitrile) base, oil and aromatic fluid resistant medium cellular rubber.

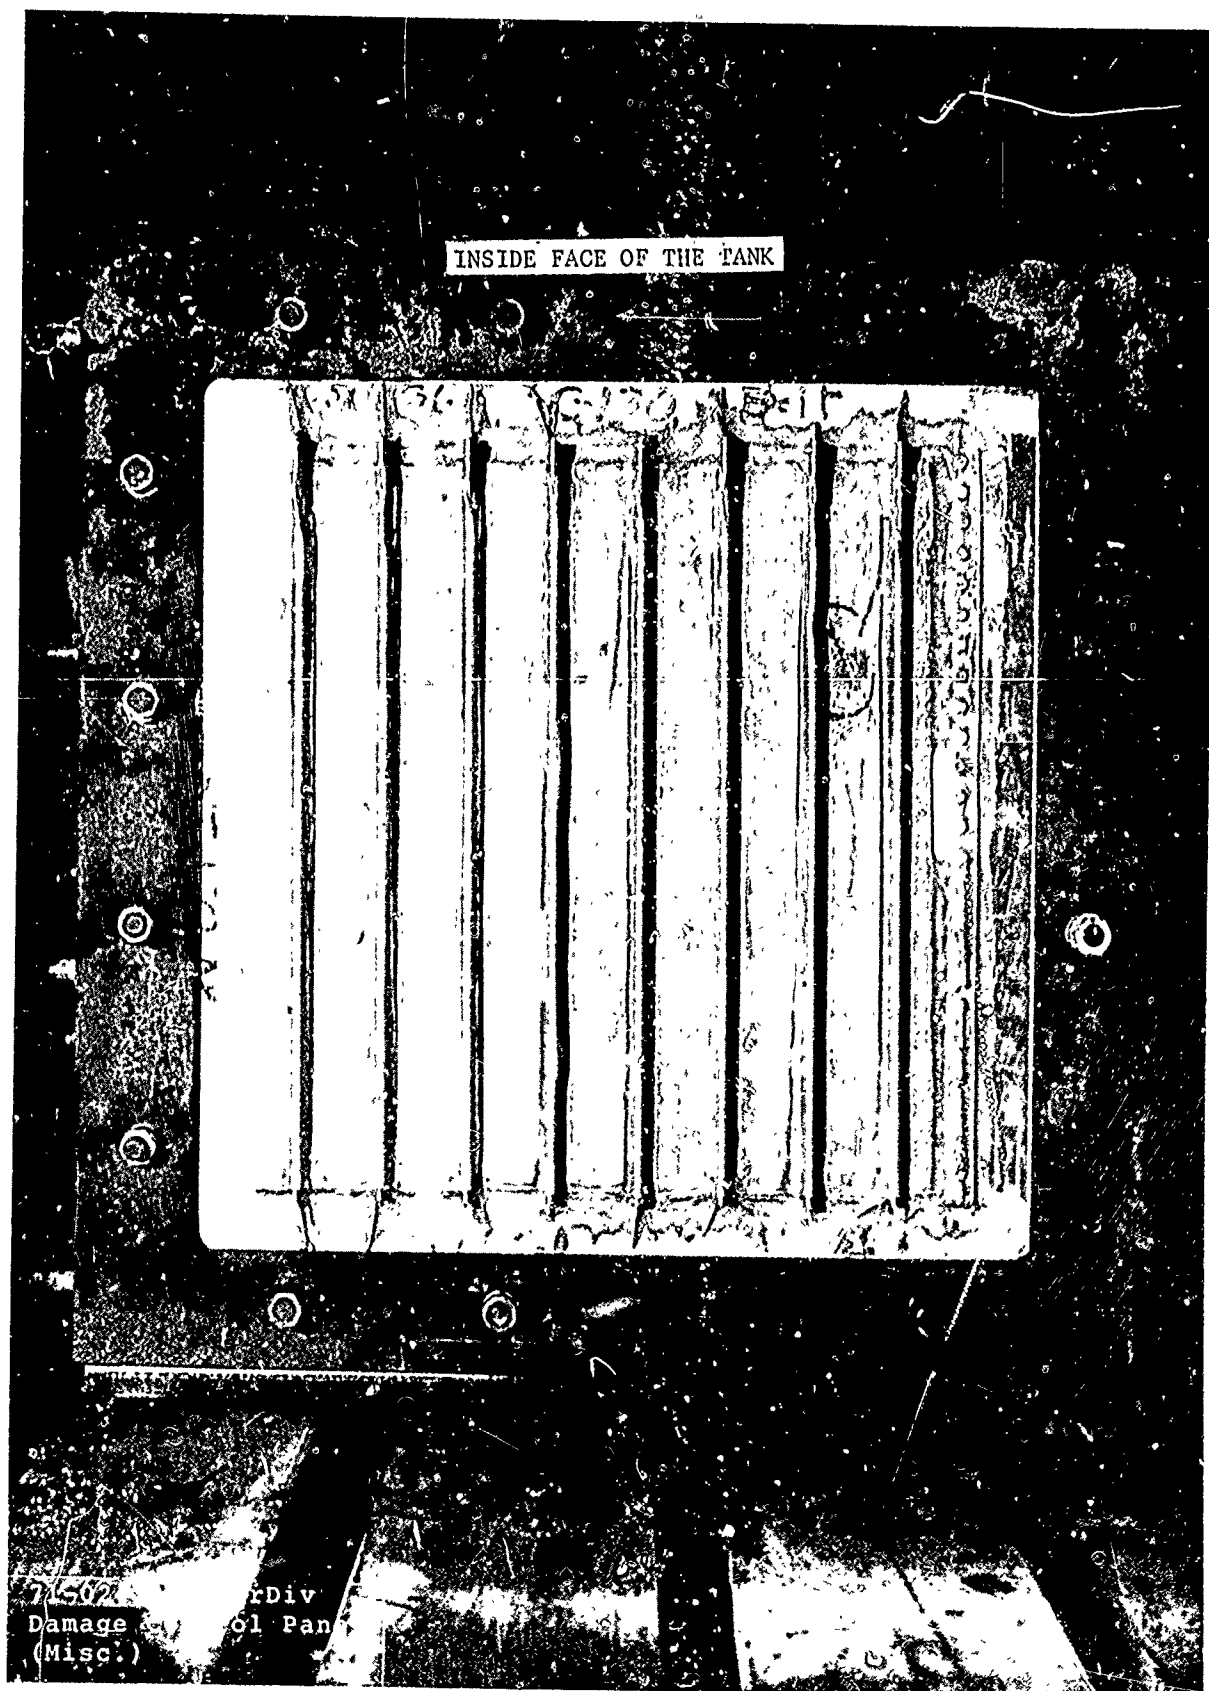
FIGURE 7. C-130 PANEL WITH DAMAGE CONTROL PROTECTION -
EXIT SIDE (INSIDE FACE OF THE TANK)

Figure 6. At the tank exit side, the tumbling projectile hit the panel between two ribs and left a 1 3/4-inch-long slit in the laminate (Figure 7). The panel skin showed a 2 1/2-inch X 1-inch hole with some petalling (Figure 8). In the case where the projectile hit a rib of the panel at the tank entry side, the rib ruptured and was deformed. The corrugated laminate kept the damage low and reduced the entry hole to the point where it almost sealed. This can be seen in Figures 9 and 10. The panel at the tank exit side was hit by the tumbling projectile which did not penetrate the panel skin. This is illustrated in Figures 9 and 10.

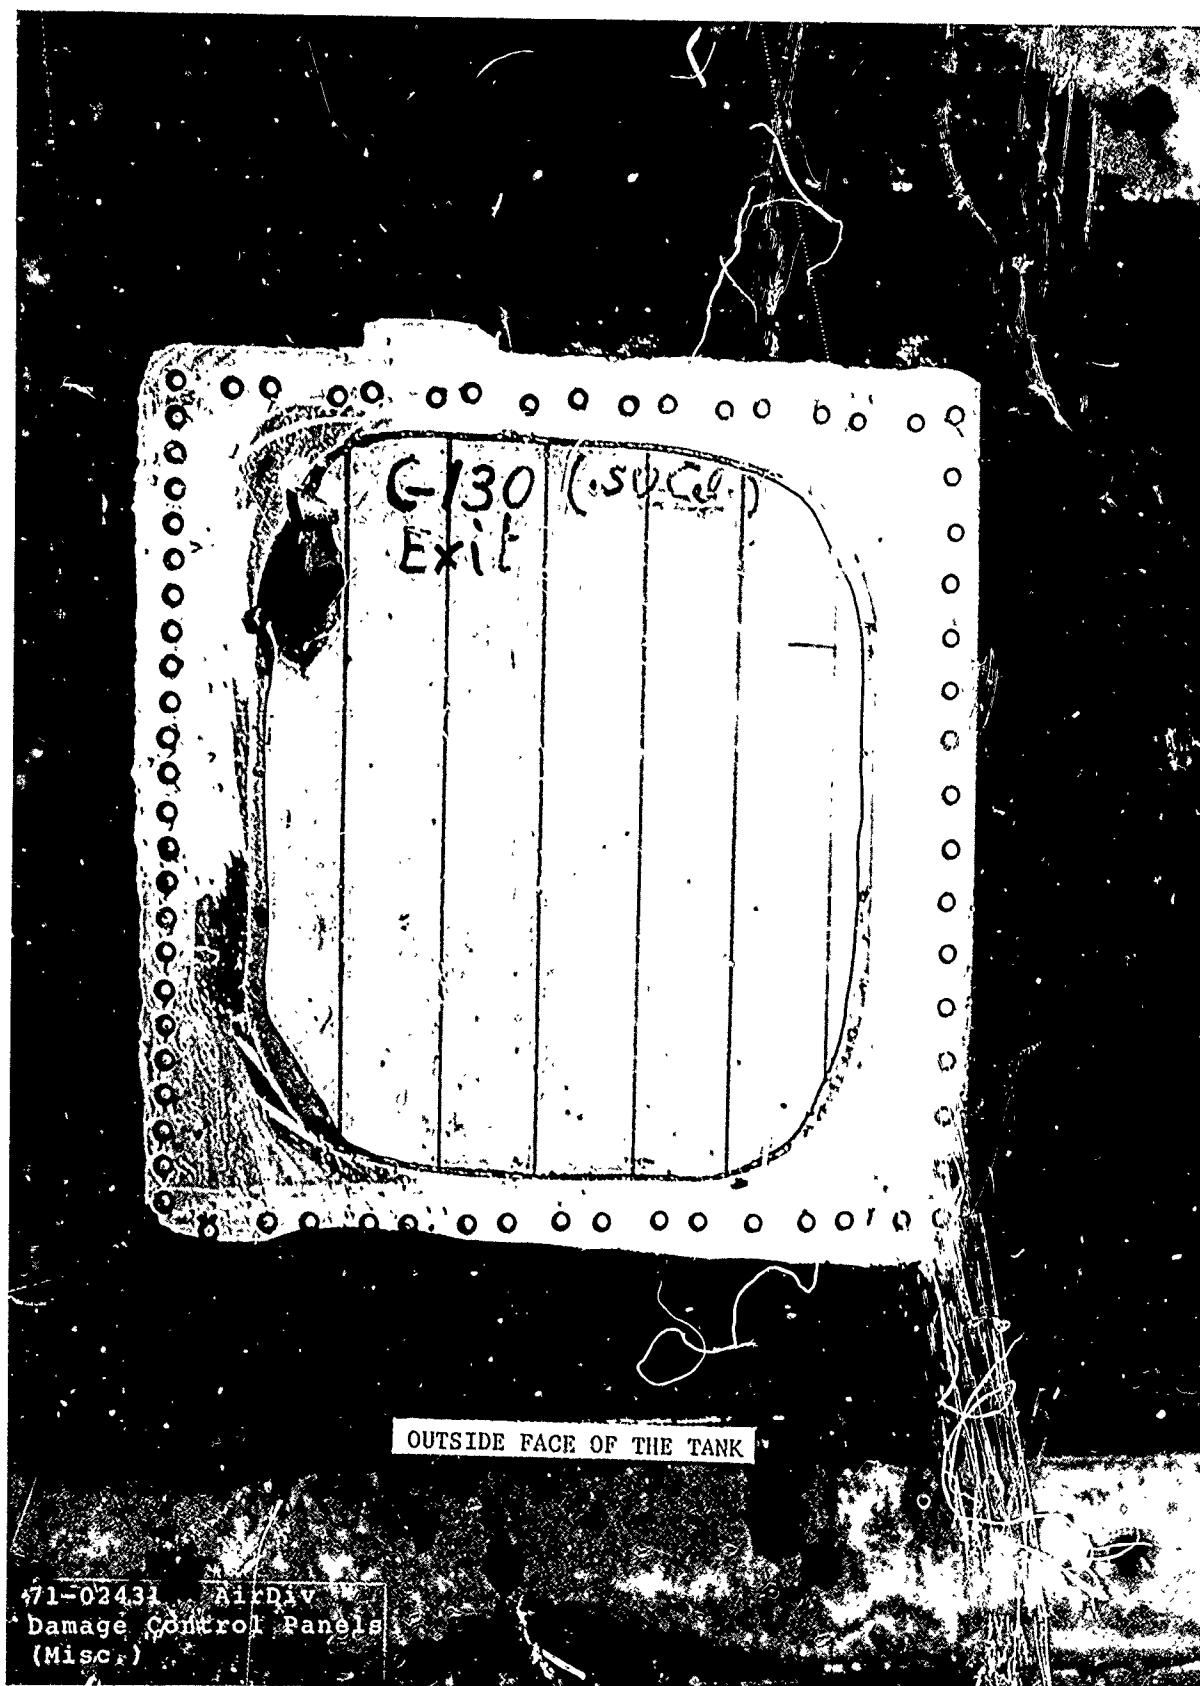
FIGURE 8. C-130 PANEL WITH DAMAGE CONTROL PROTECTION - EXIT SIDE
(OUTSIDE FACE OF THE TANK)

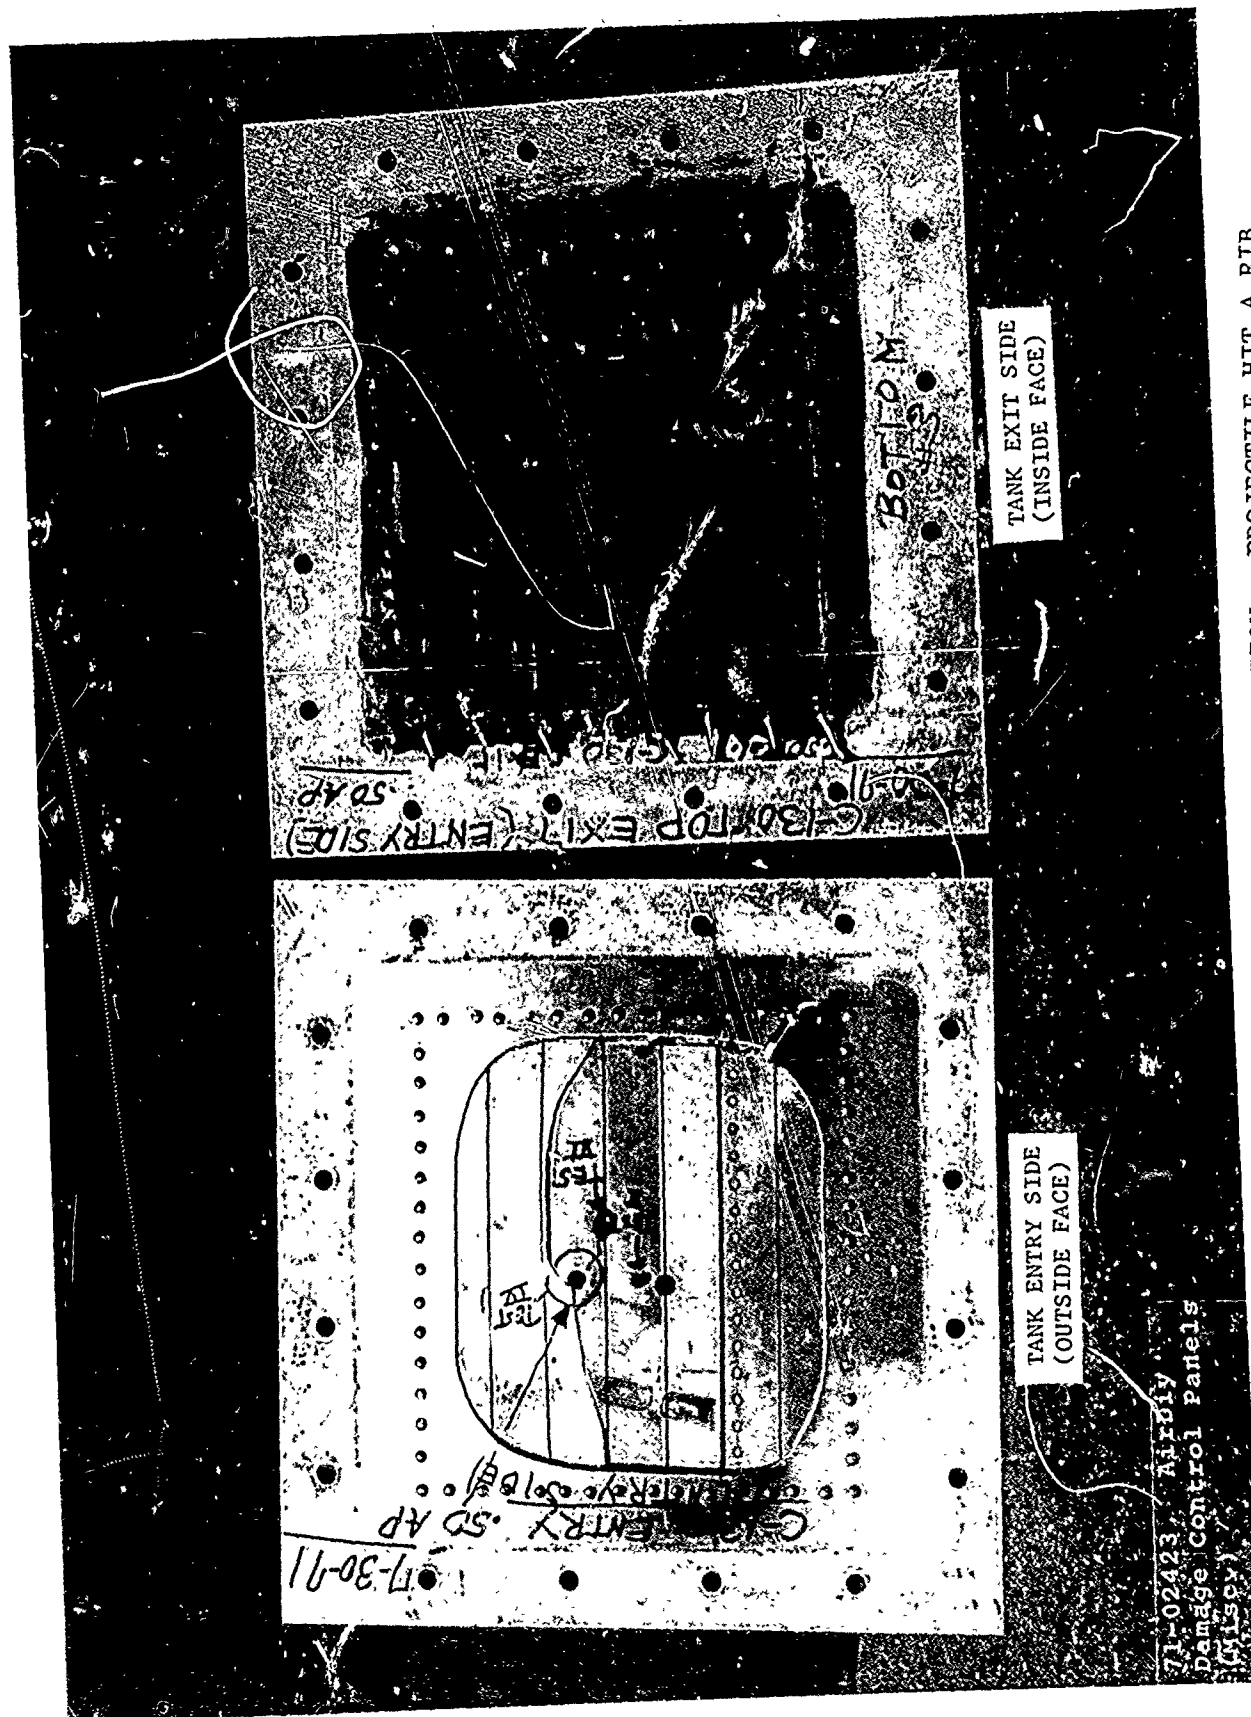
FIGURE 9. C-130 PANEL WITH DAMAGE CONTROL PROTECTION - PROJECTILE HIT A RIB AT ENTRY (OUTSIDE FACE OF ENTRY AND INSIDE FACE OF EXIT ARE SHOWN)

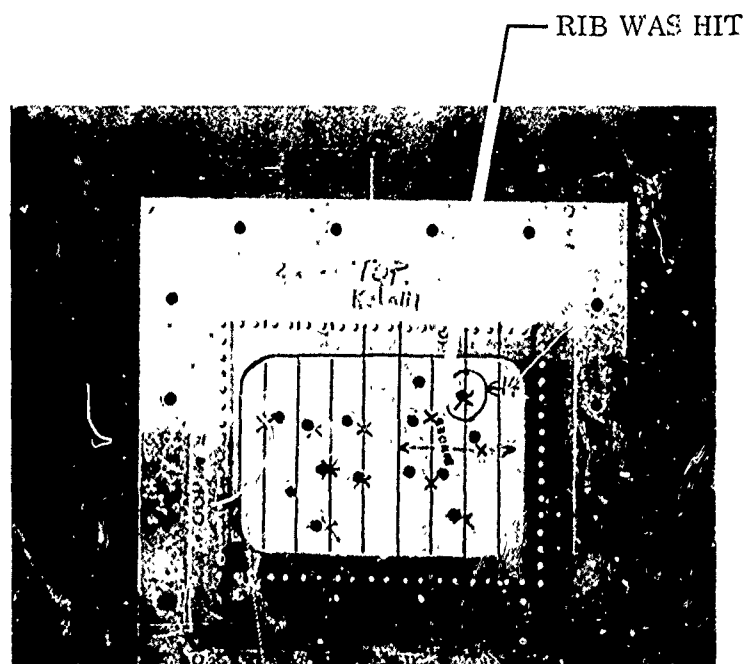
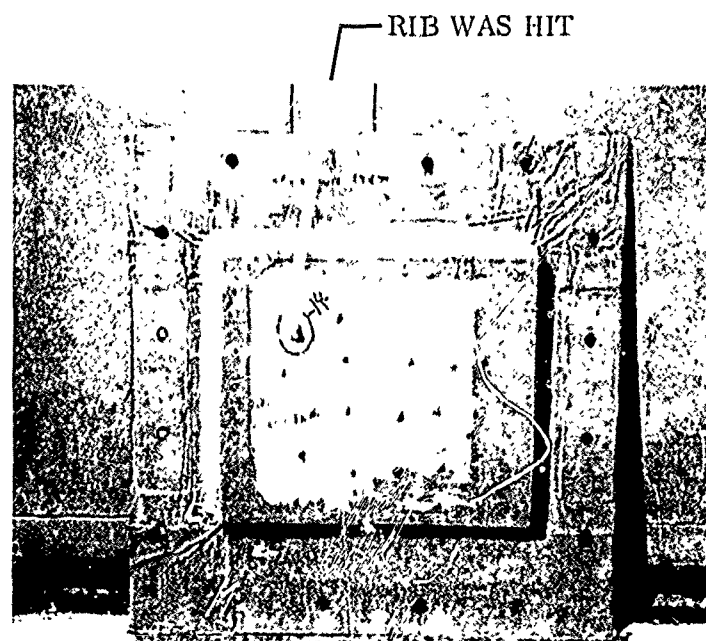
FIGURE 11. C-130 WING PANEL WITH DAMAGE CONTROL AND SELF-SEALING SYSTEMS MOUNTED (90° ANGLE OF INCIDENCE IMPACTS)

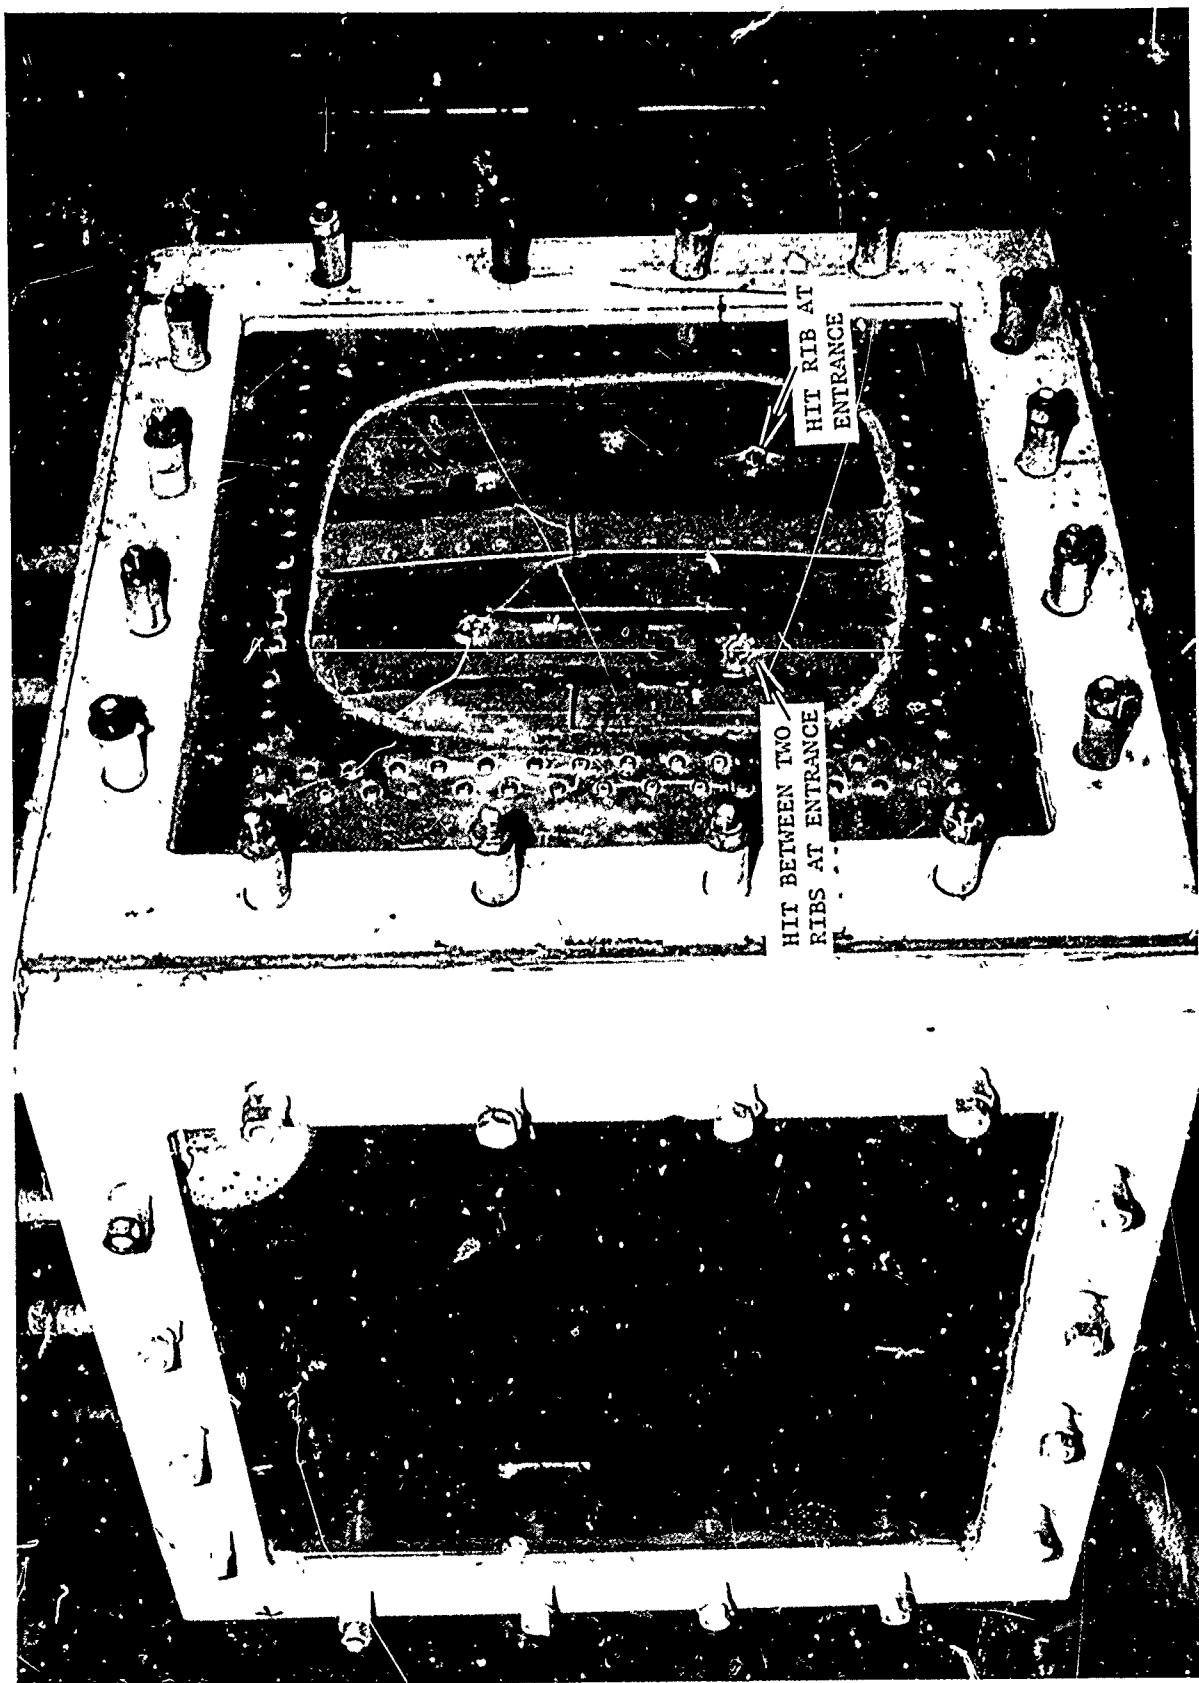
FIGURE 12. C-130 WING PANEL WITH DAMAGE CONTROL AND SELF-SEALING SYSTEMS MOUNTED -
45° ANGLE OF INCIDENCE IMPACTS (OUTSIDE FACE OF ENTRY PANEL)

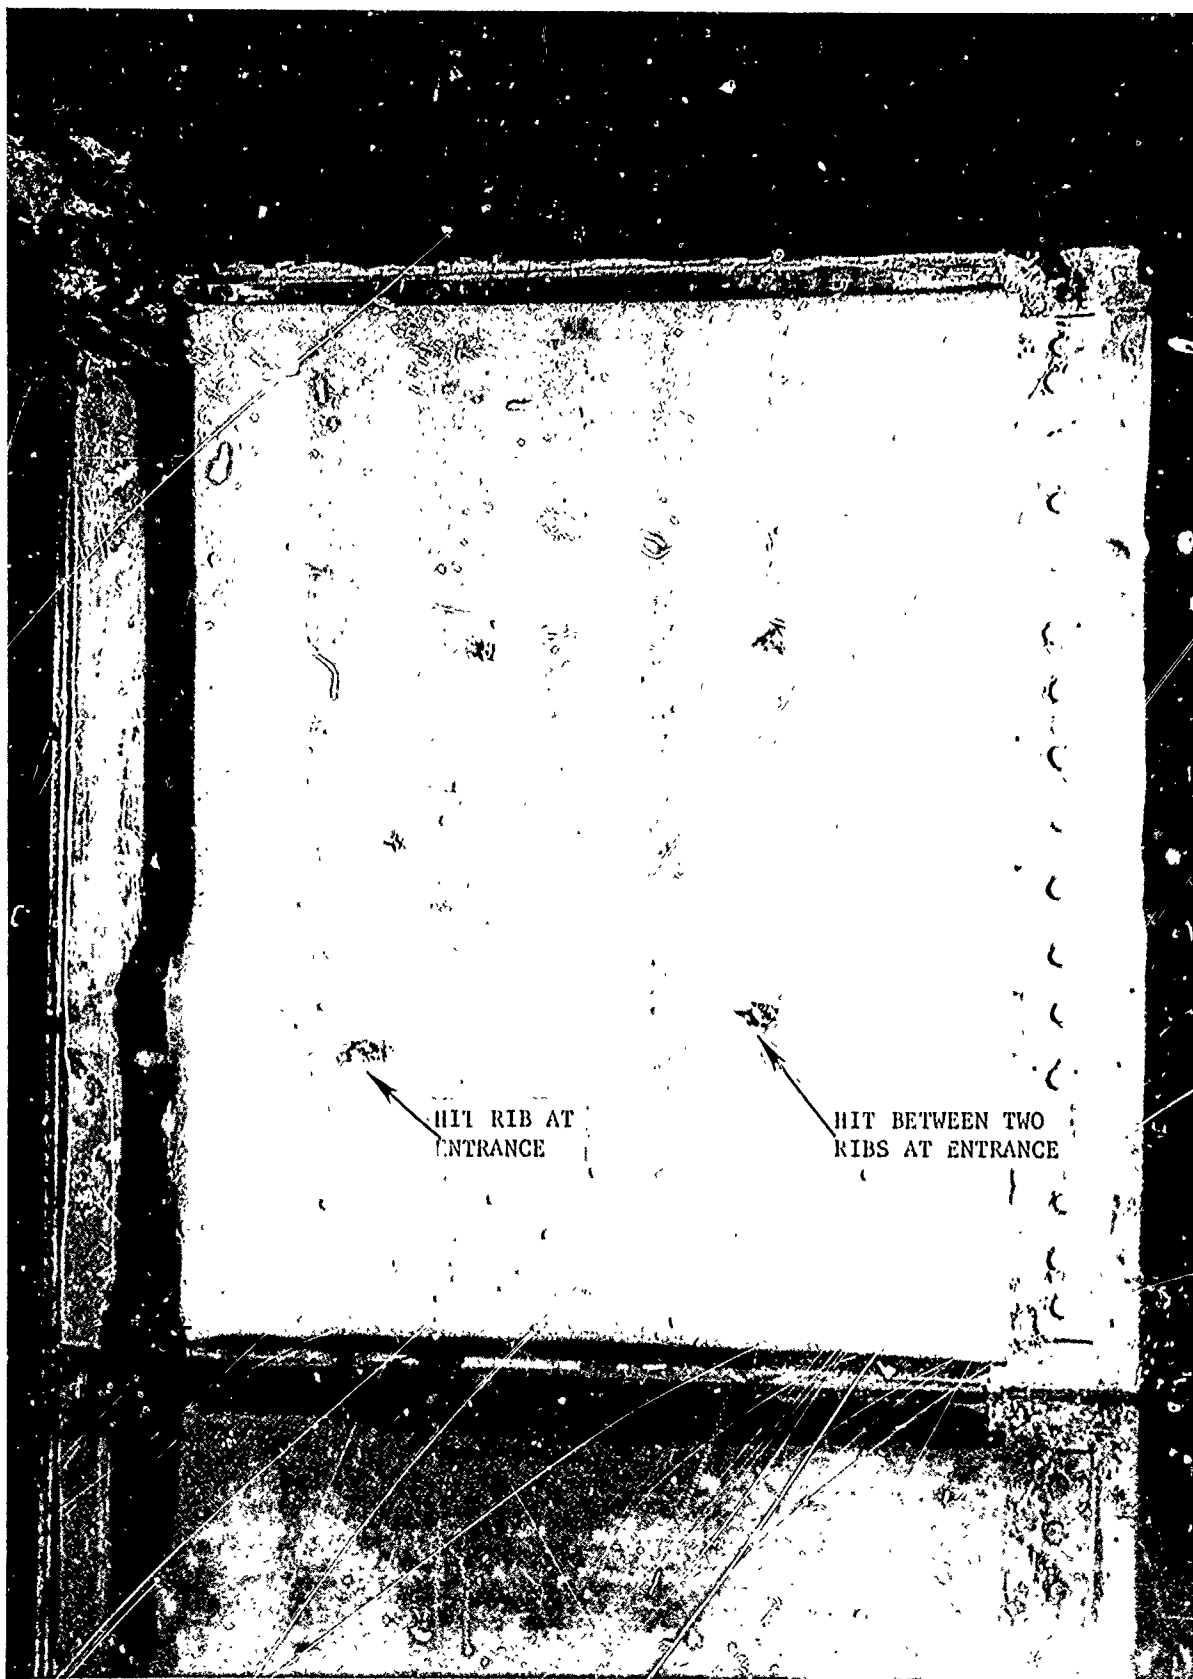
FIGURE 13. C-130 WING PANEL WITH DAMAGE CONTROL AND SELF-SEALING SYSTEMS MOUNTED - 45° ANGLE OF INCIDENCE IMPACTS (INSIDE FACE OF ENTRY PANEL)

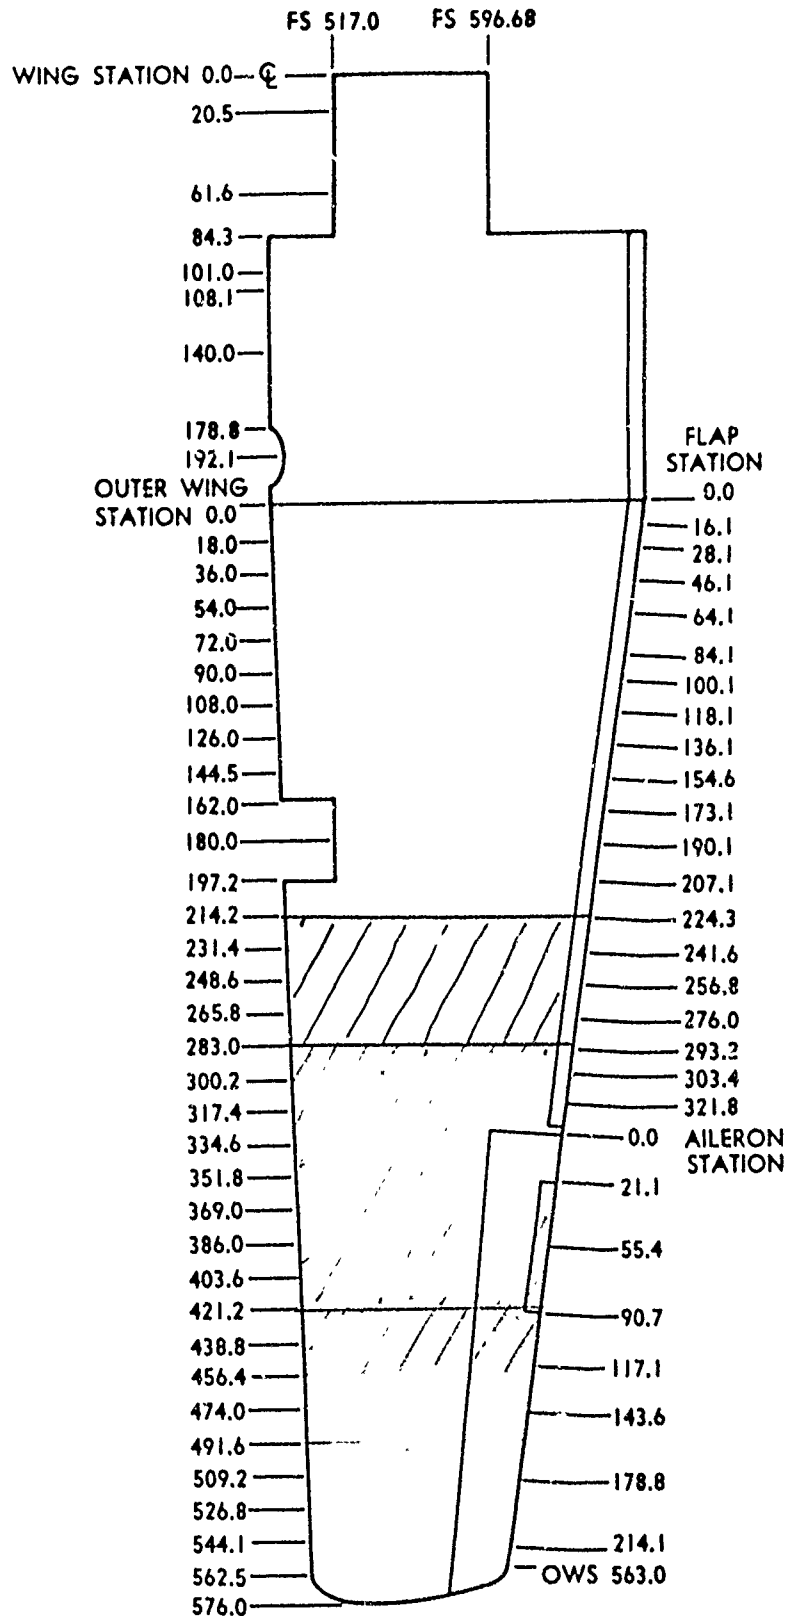
FIGURE 14. AIRPLANE WING STATIONS

The wing section received from Lockheed, Marietta, was uncrated and mounted on a fixture for disassembly and cutting. All internal plumbing, fuel system components, and trailing edge fairings were removed. The wing section was cut in two places, forming three separate tanks, as shown in Figure 14. Tank number one extended from OWS 214 to OWS 283; tank number two extended from OWS 283 to OWS 421; and tank number three extended from OWS 421 to OWS 562.

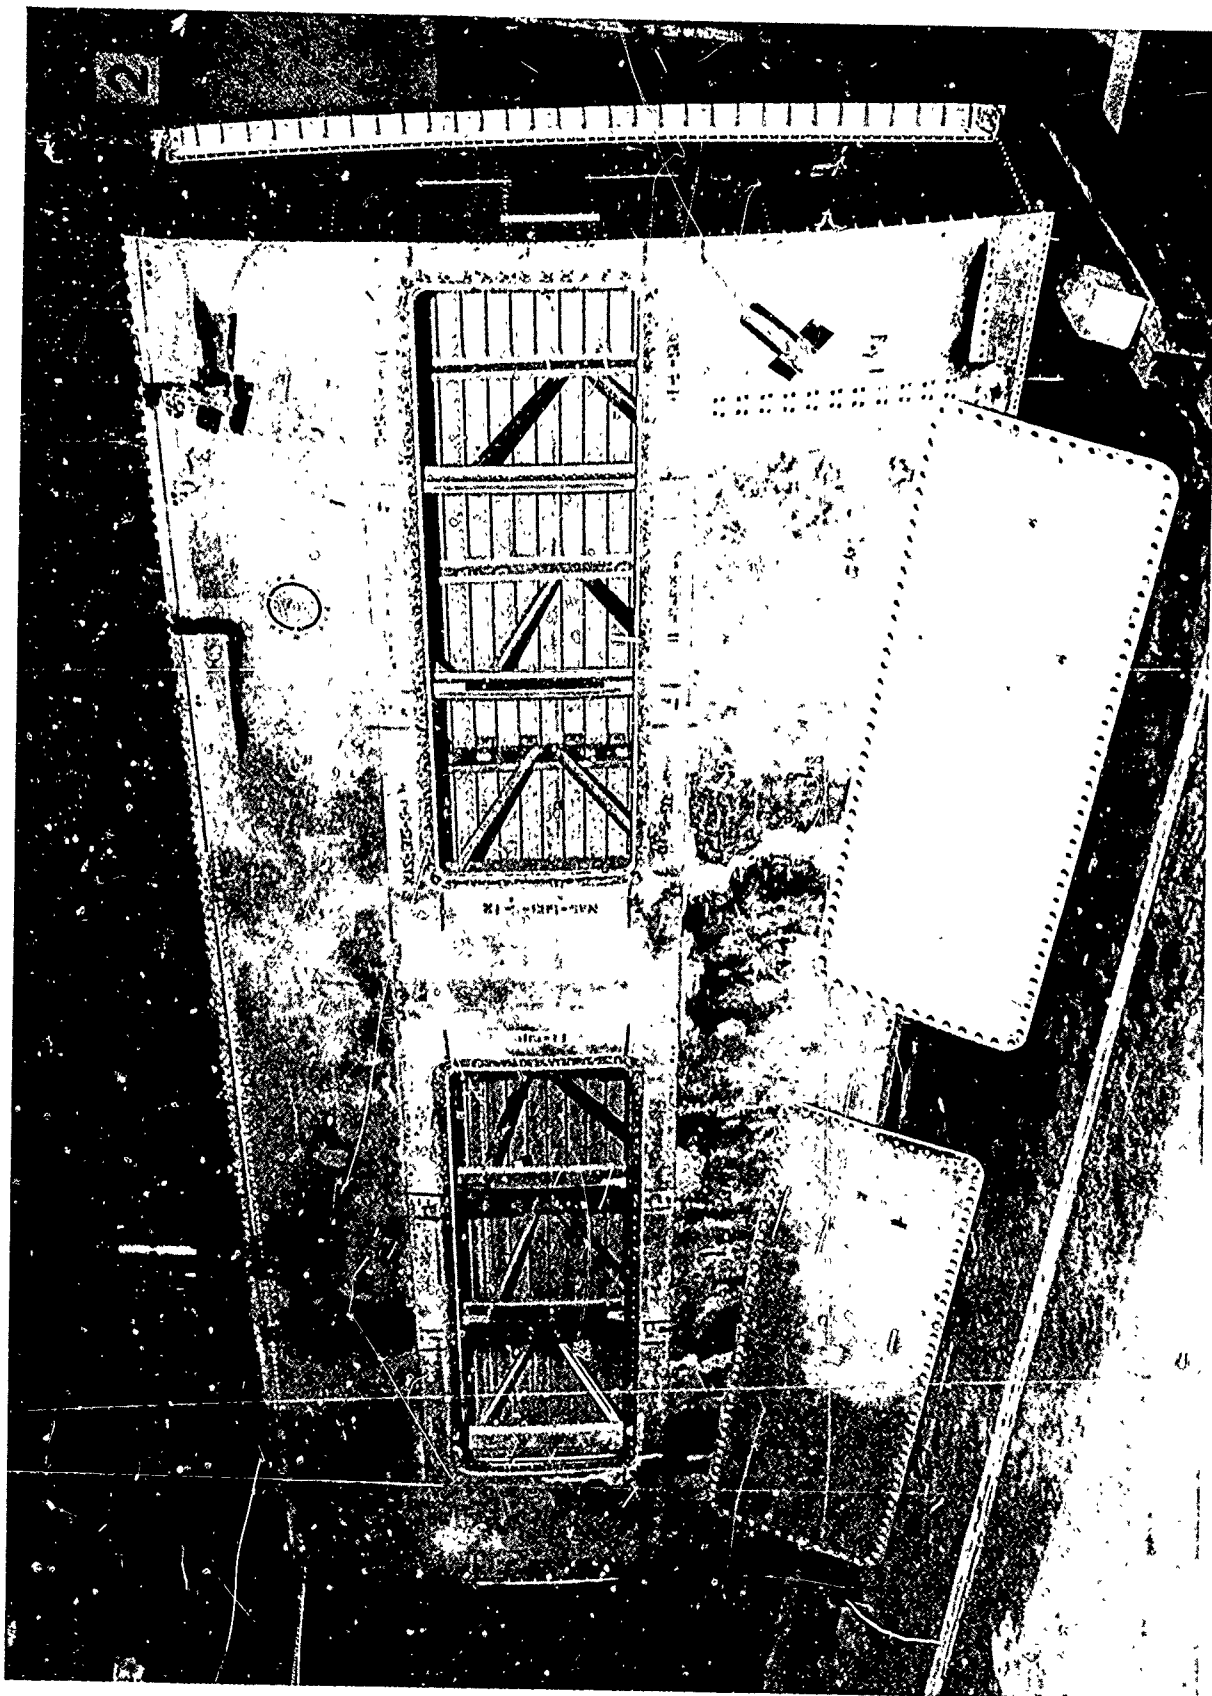
FIGURE 16. C-130 FIRING TEST WING TANK

Closeout plates, clips and stiffeners were fabricated and installed into the number two tank (OWS 283 to OWS 421) to seal off the ends and holes left after removal of the fuel system components. This tank, which was used for the firing tests, is shown in Figure 16. The skin thickness of this tank varied from .050 to .064 inch and the rib thickness measured from 1/16 to 3/32 inch.

As can be seen in Figures 15 and 16, which show the slosh and vibration test tank and the firing test tank, one side of each tank is tapering off as one proceeds in the outboard direction. The other side remains straight or untapered. On the untapered side, the corners, from one bay to the next,
